U.S. DEPARTMENT OF
ENERGY

Legacy
Management

2021 Annual Site Inspection and Monitoring Report for Uranium Mill Tailings Radiation Control Act Title I Disposal Sites

March 2022

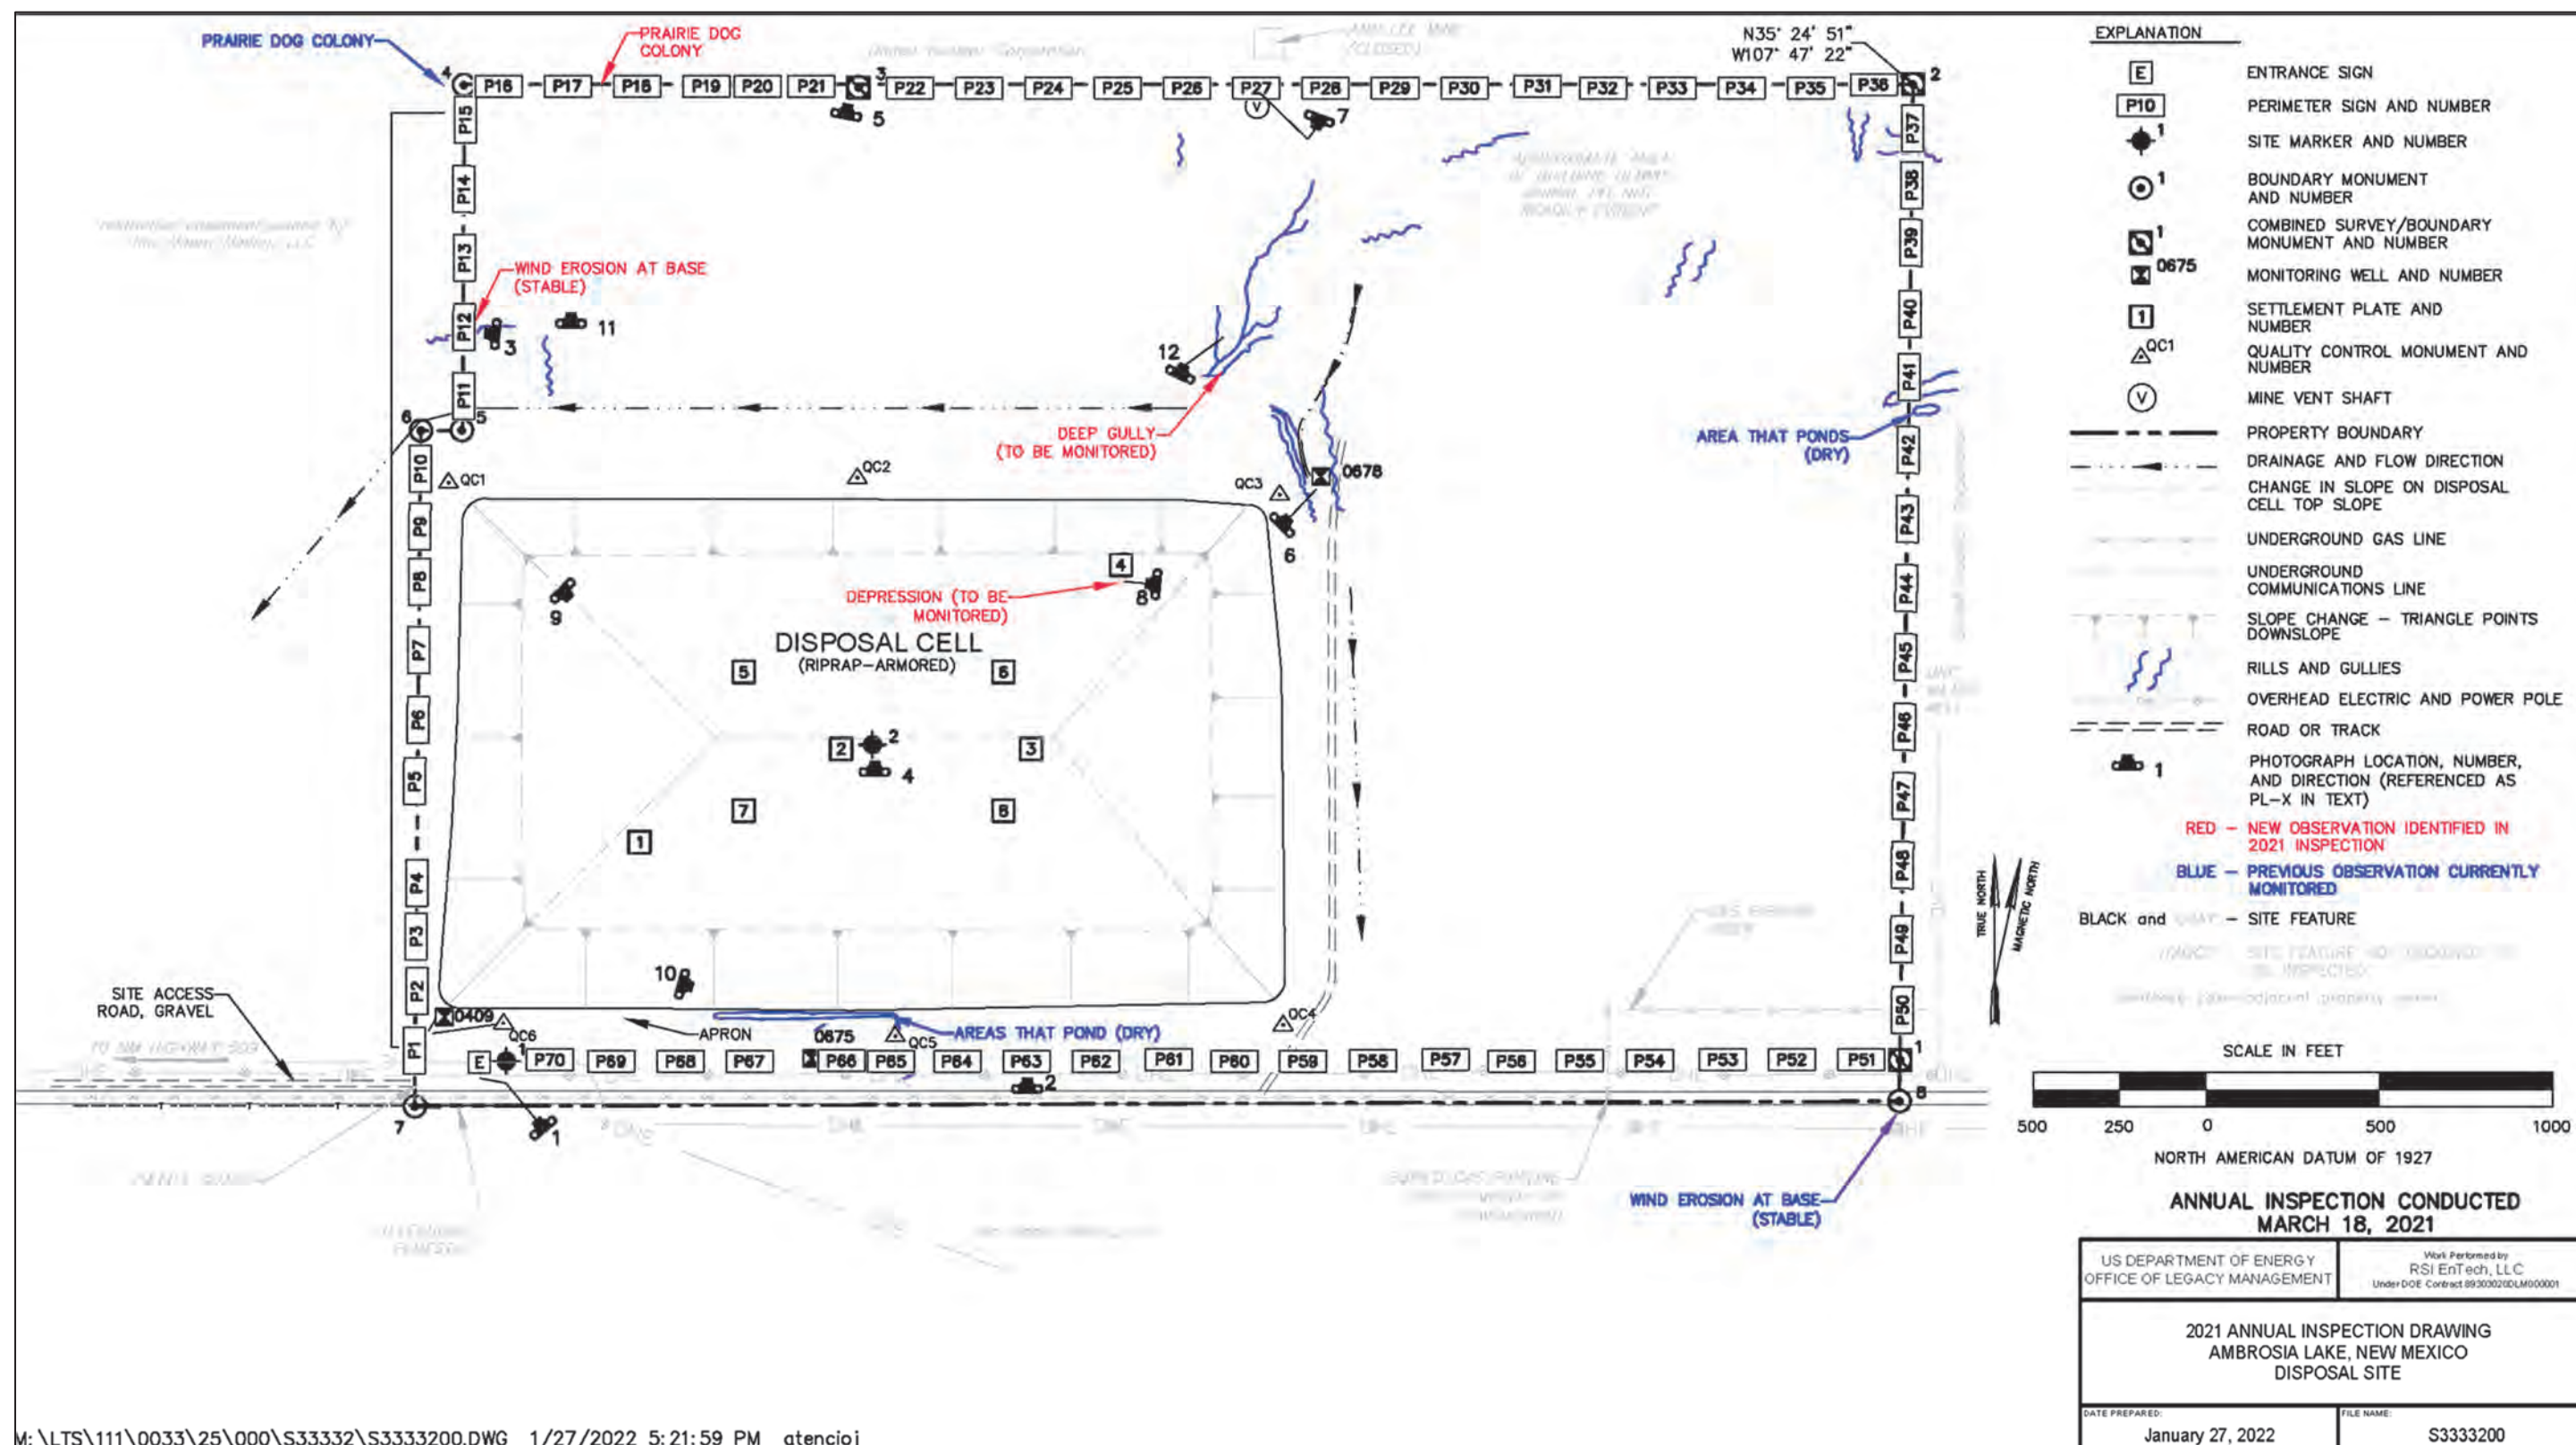
Figure 1-1. 2021 Annual Inspection Drawing for the Ambrosia Lake, New Mexico, Disposal Site

Figure 1-1 shows the locations of site features, including site surveillance features and inspection areas, in black and gray font. Site features that are present but not required to be inspected are shown in italic font. Observations from previous inspections that are currently monitored are shown in blue text, and new observations identified during the 2021 annual inspection are shown in red. Inspection results and recommended maintenance activities associated with site surveillance features are included in the following subsections. Photographs to support specific observations are identified in the text and in Figure 1-1 by photograph location (PL) numbers. The photographs and photograph log are presented in Section 1.10.

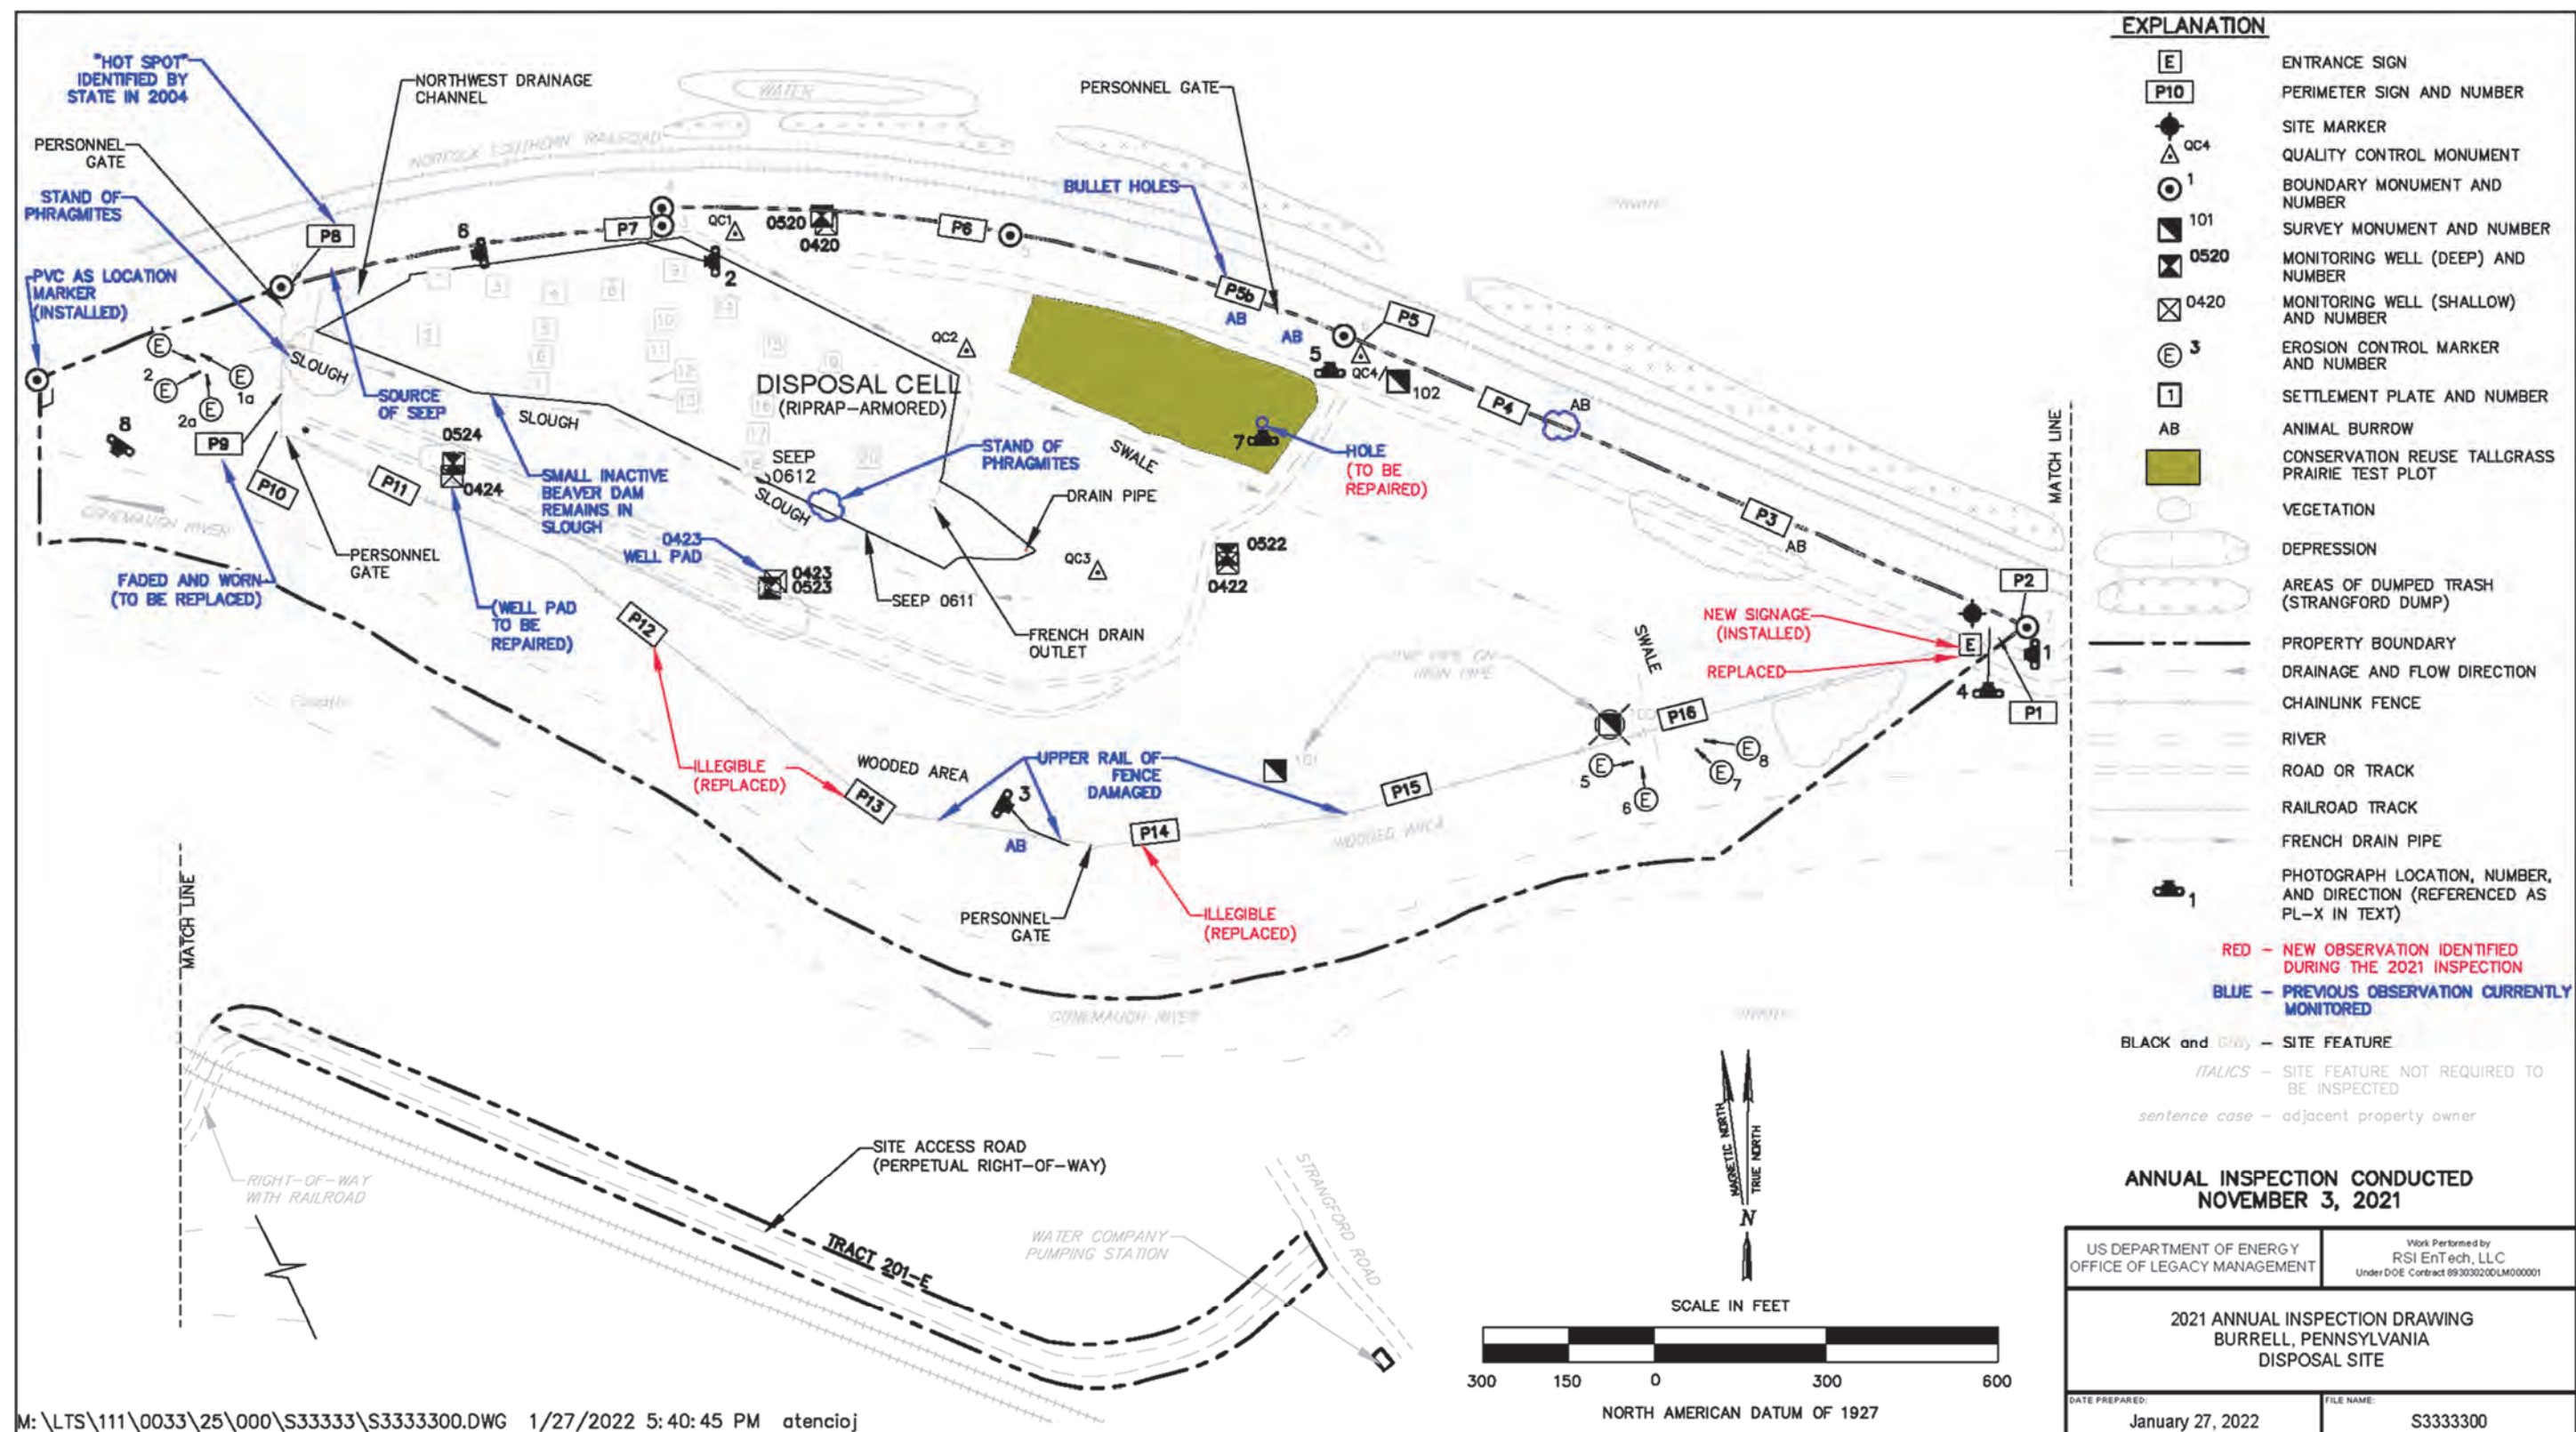
Figure 2-1. 2021 Annual Inspection Drawing for the Burrell, Pennsylvania, Disposal Site

Figure 2-1 shows the locations of site features, including site surveillance features and inspection areas, in black and gray font. Site features that are present but not required to be inspected are shown in italic font. Observations from previous inspections that are currently monitored are shown in blue text, and new observations identified during the 2021 annual inspection are shown in red. Inspection results and recommended maintenance activities associated with site surveillance features are included in the following subsections. Photographs to support specific observations are identified in the text and in Figure 2-1 by photograph location (PL) numbers. The photographs and photograph log are presented in Section 2.10.

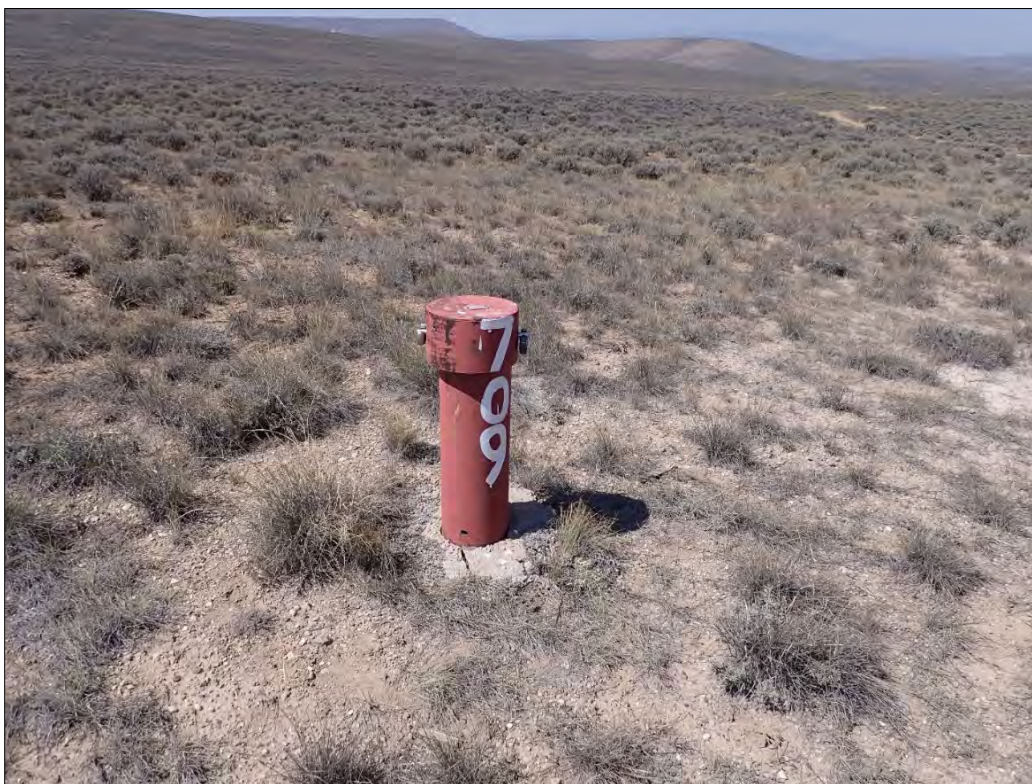
PL-4. Cracked Base of Well 0709

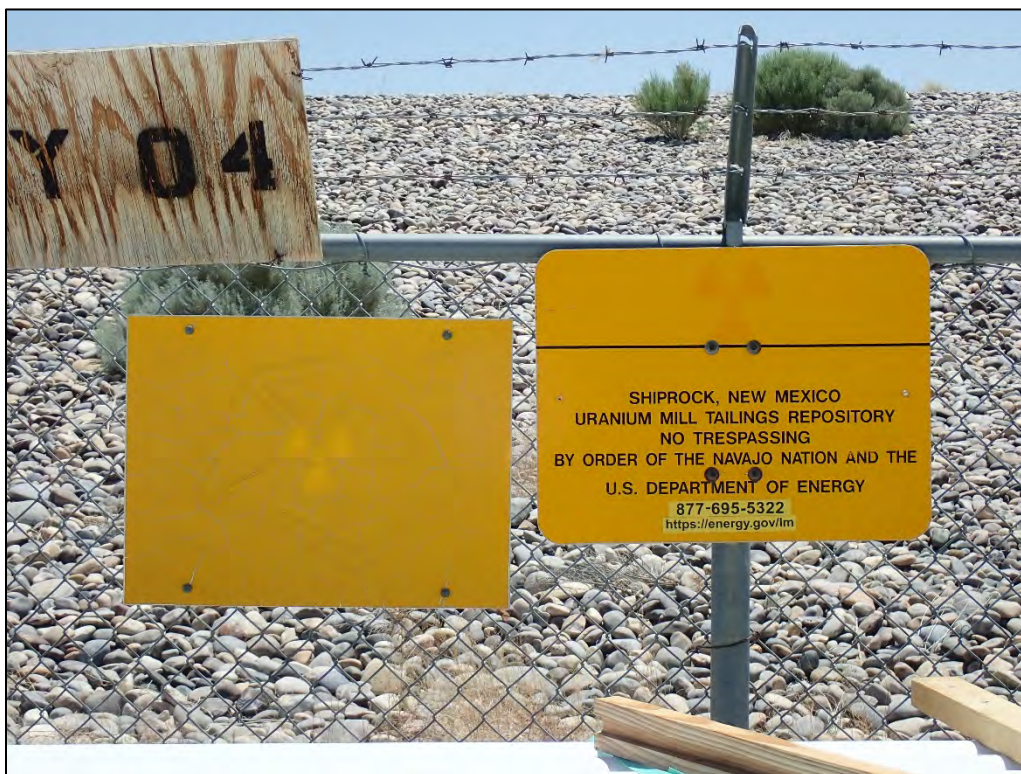
PL-1. Faded Pictorial Sign and Radiation Symbol on Perimeter Sign P12

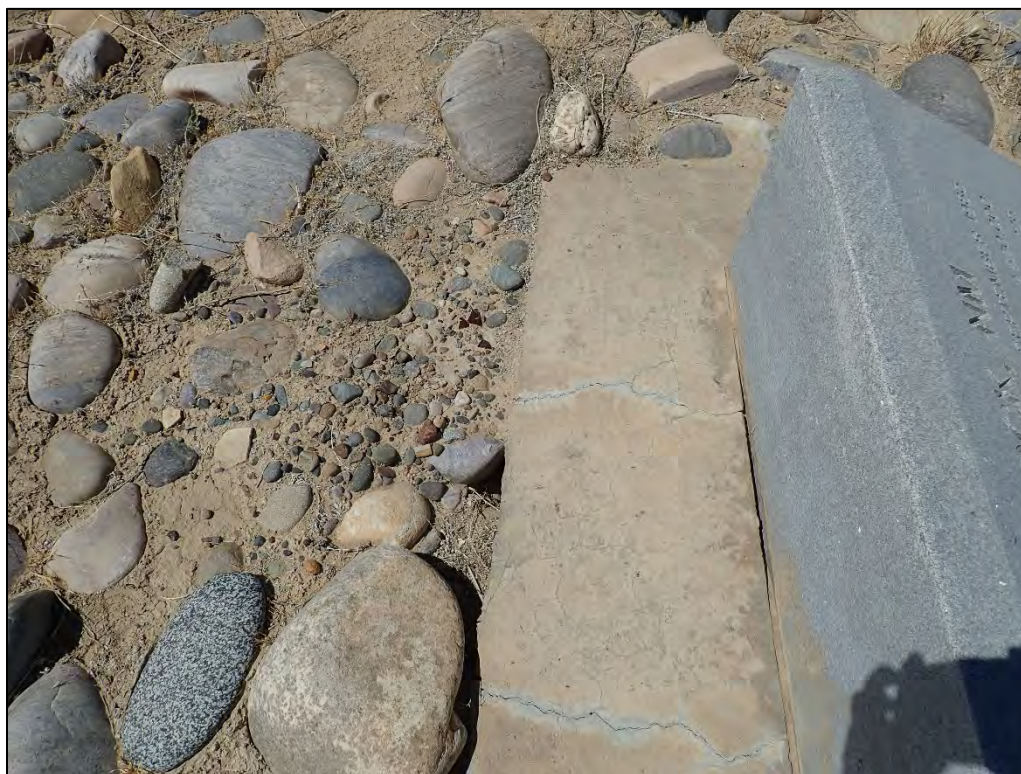
PL-2. Cracks and Erosion in Concrete Base of Site Marker SMK-1

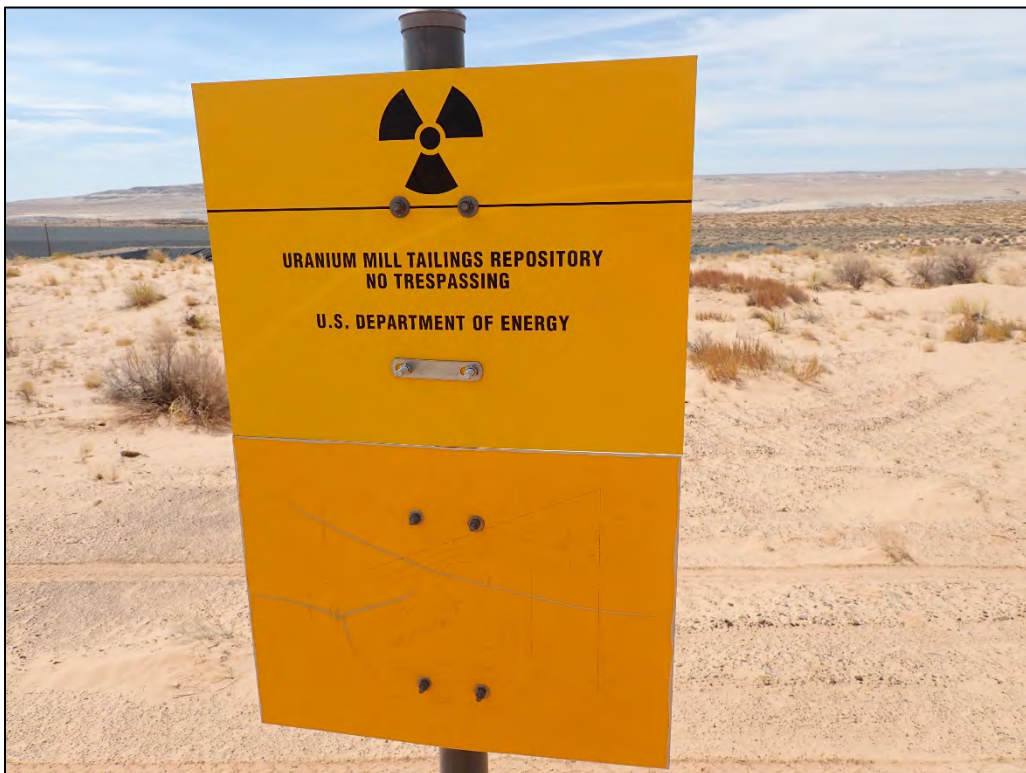
PL-2. Faded and Cracked Pictorial Perimeter Sign P6
